# *Israel Nature and Parks Authority*

## *The Conservation of the Archeological Parks*

### *The use of St. Astier Natural Hydraulic Limes*

### *First Preliminary Report*

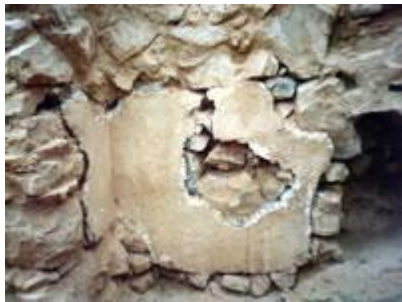
2000 year-old lime plaster, miraculously surviving and urgently awaiting conservation treatment.

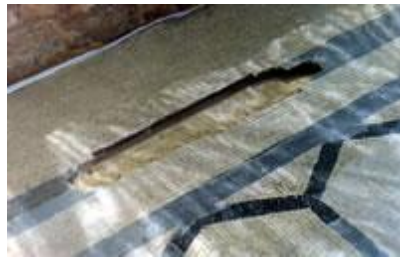
Mosaic floor during careful conservation treatment.

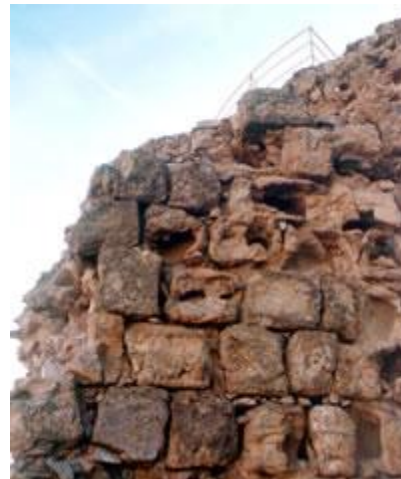
Soft-stone facade deteriorated to point of collapse.

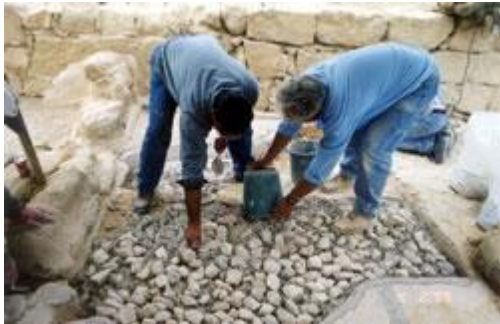
Bedding for a lime floor surrounding a  
mosaic

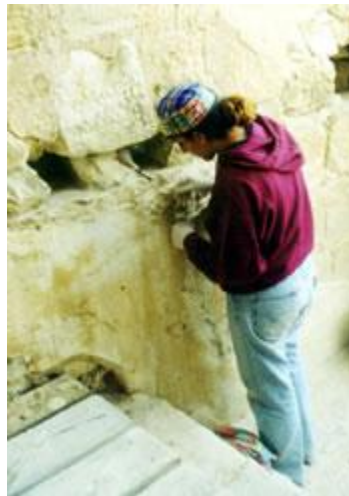
Conservation of fragile lime wall plasters

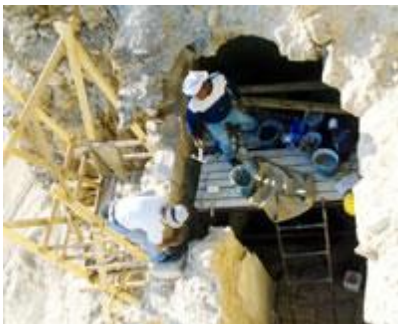
Reconstruction of a vault  
of a Bath-House on the  
edge of a 400 metre abyss

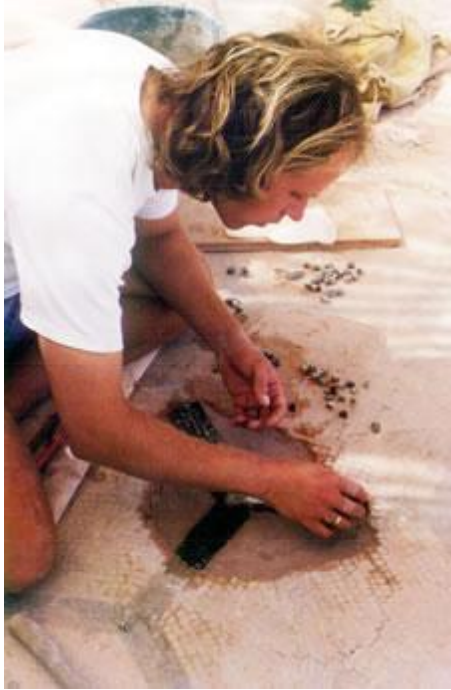
Replacement of tesserae

- Injecting and filling of voids in bedding - NHL-2
- Replacement of tesserae - NHL-3.5
- Filling lacunae - NHL-3.5
- Filling joints between tesserae - NHL-2
- Closing of borders - NHL-3.5

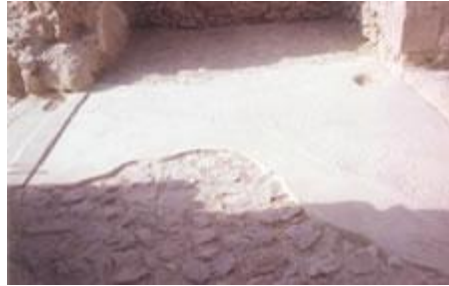
Stabilised mosaic in passage-way allowing visitors to walk on

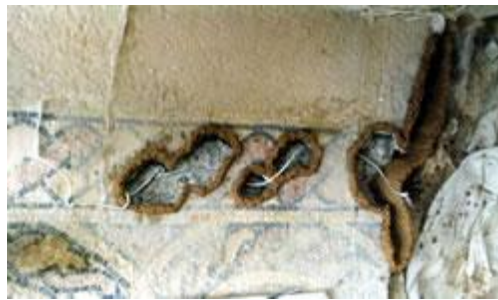
Injecting and filling of voids under the mosaic

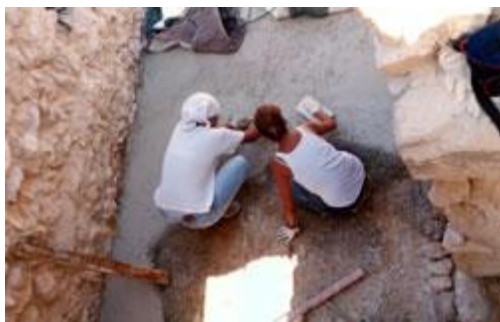
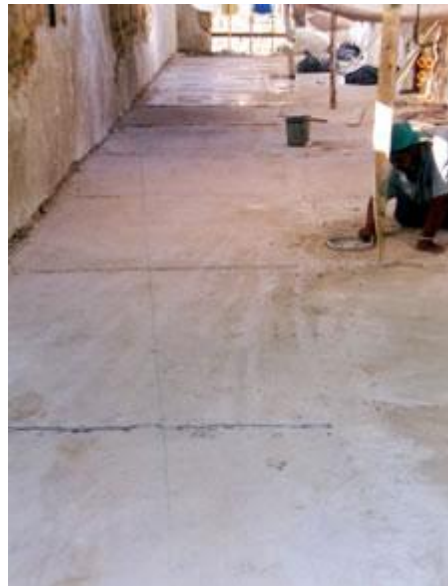
Repaving of floors allowing passage of visitors directly on floors as in ancient times. The original remains have been documented, stabilised and protected.

- Stabilization of original - NHL-2
- Integration to original - NHL-2
- Reconstruction of bedding - NHL-5
- Repaving of floors for walking - NHL-5

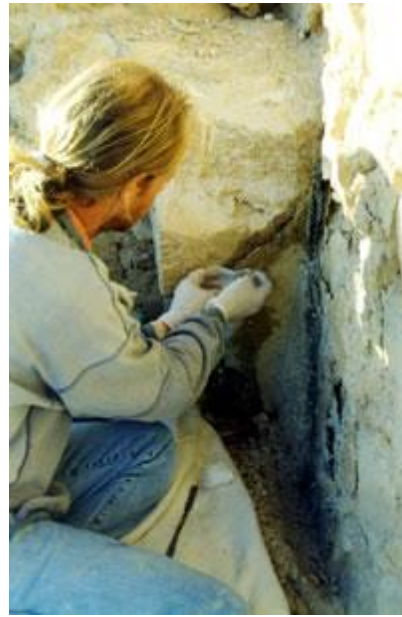
Filling of borders and cracks.

- Consolidation by injection - NHL-2/NHL-3.5
- Integration to original - NHL-2.
- Filling of borders, cracks - NHL-2.
- Re-plastering of walls - NHL-2.

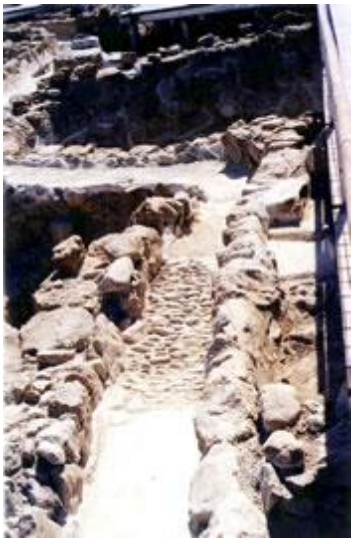
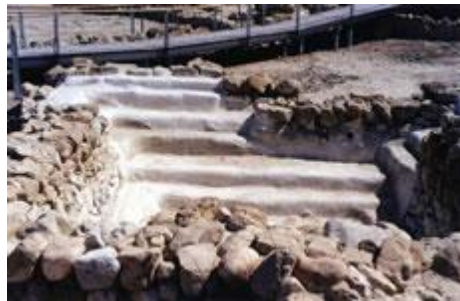
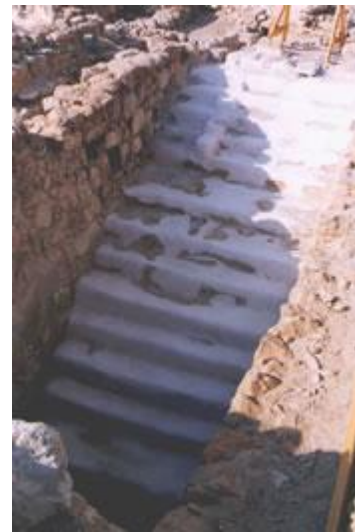
Conservation of the plasters in the water system of Qumeran

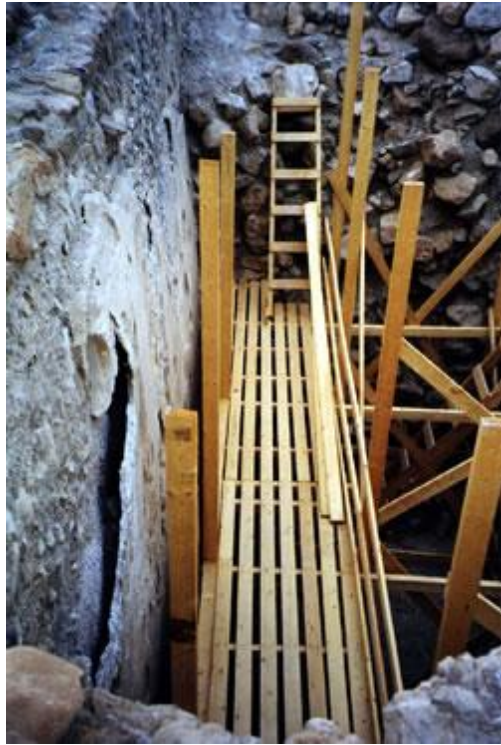
One of the greatest challenges was an unusually large render panel in one of the grand pools which was detached more than 10 cm from bedding and wall and miraculously survived and waited for treatment.

The large panel on the wall of the grand pool detached by uncontrolled flood waters from above.

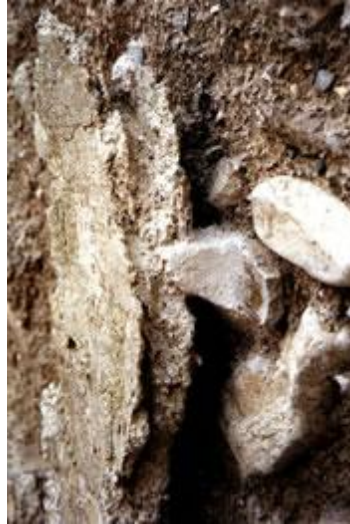
Example of lime fasteners

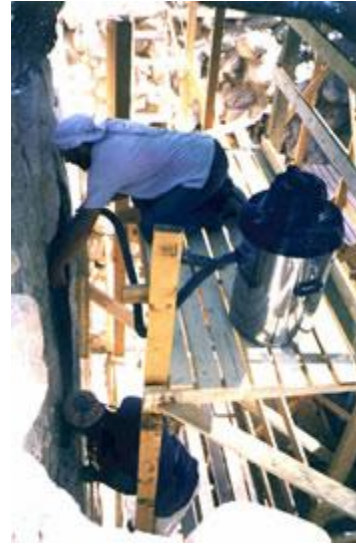
The careful cleaning of the huge void after securing the panel with lime fasteners and gauze with weak solution of acrylic resin

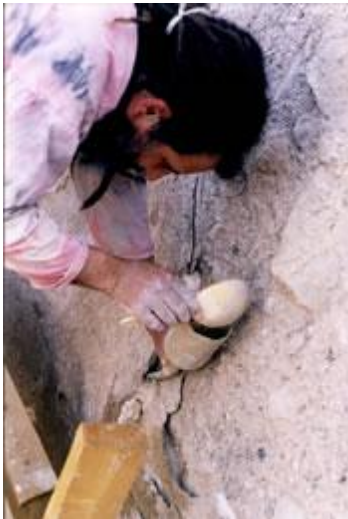
Filling of the voids from all directions with liquid mortar made of NHL - 2 and pieces of light-weight high fired ceramic balls and ancient pottery sherds

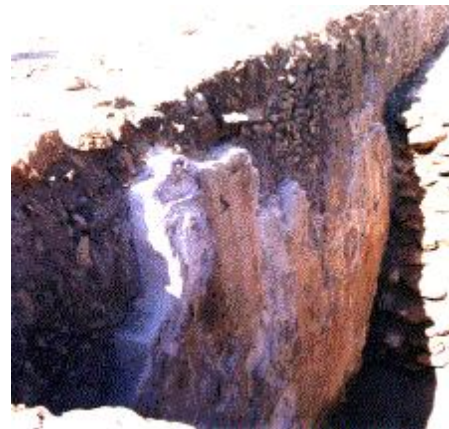
The finished result:  
A surprising and amazing success!

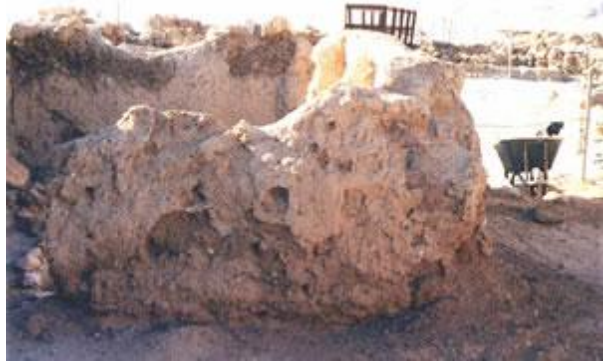
A badly deteriorated mud-brick and mud plastered wall

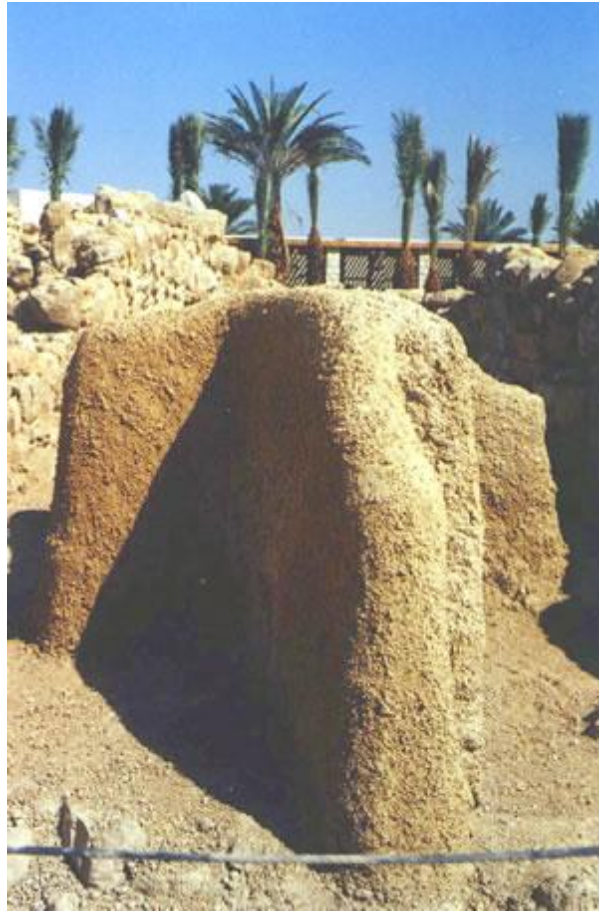
Retouching mud bricks, NHL 2/mud replastering and sacrificial protection layers

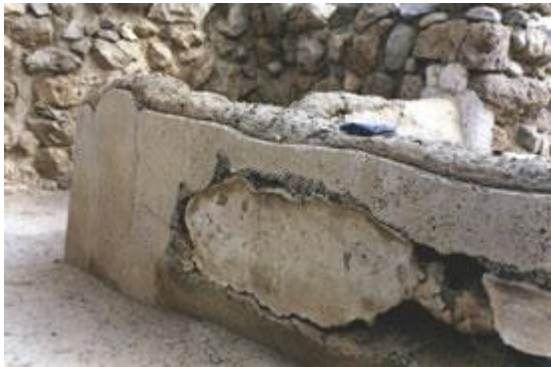
An earlier intervention with white cement causing evident damage on this ancient mud brick and lime

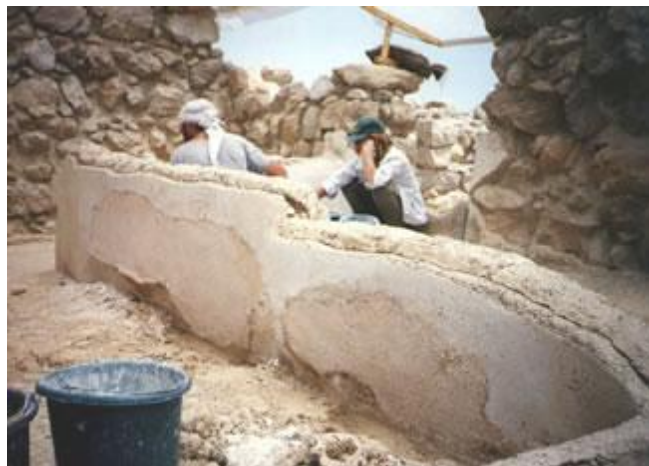
Consolidation of mud bricks and integration to original. The same wall after having removed the cement and replastered with NHL 2

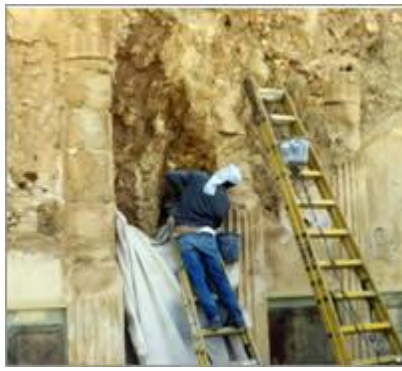
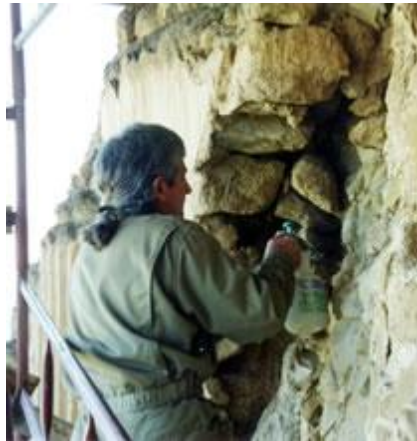
Filling "voids" in wall-core mortar.

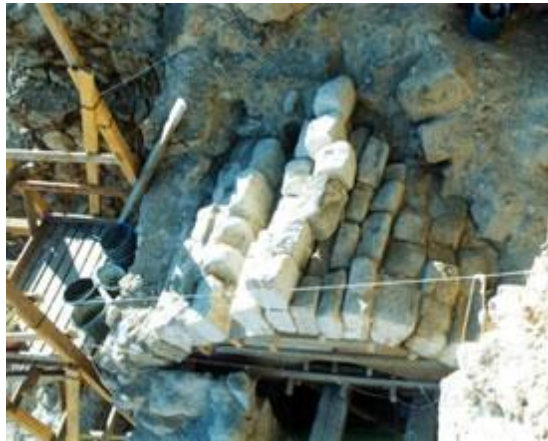
Bedding mortar in vault reconstruction.

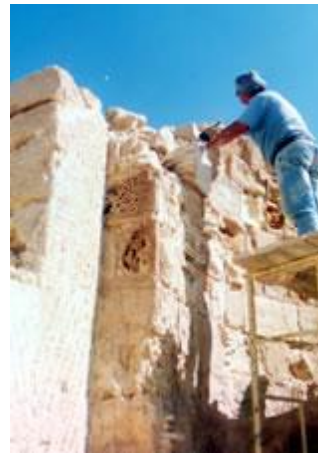
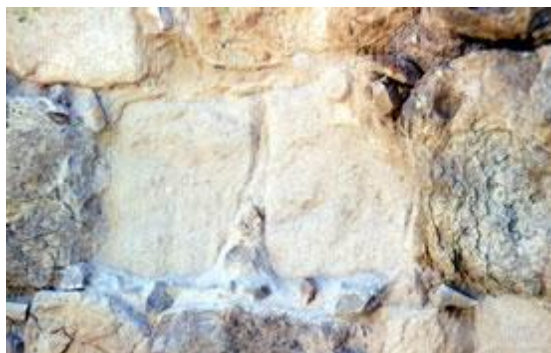
"Stone like" sacrificial layer.

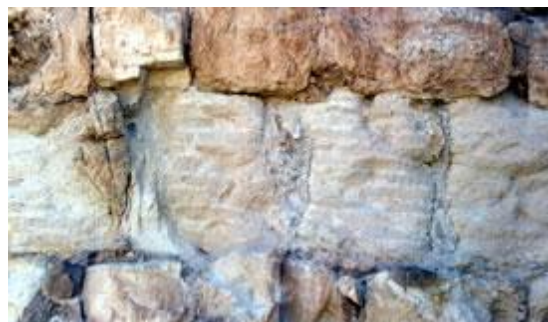
Filling of limestone tiles bedded in an NHL 2 mortar in cavernously decayed soft limestone. The pointing uses NHL 2 mortar with limestone pins.

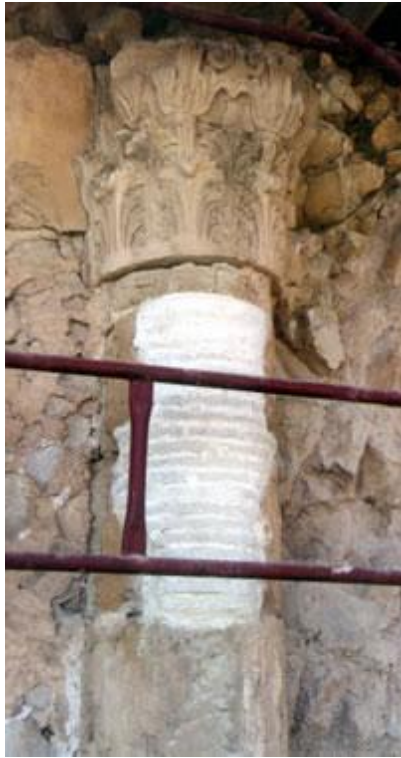
Filling of voids in columns with cast stone slabs

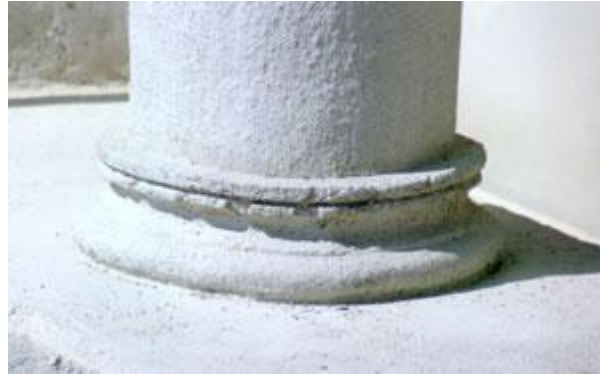
Detail of cast base before final coat.

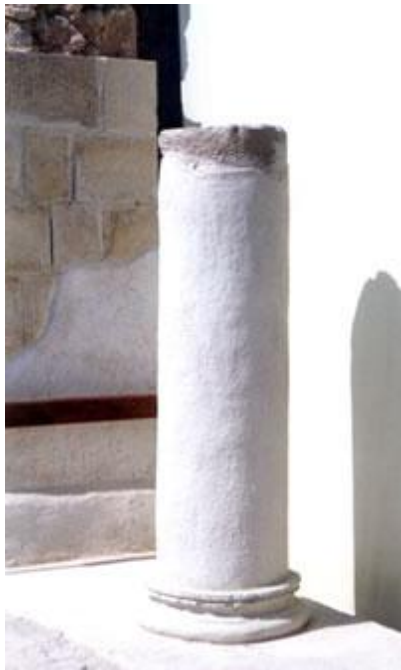
Cast, plastered column and base

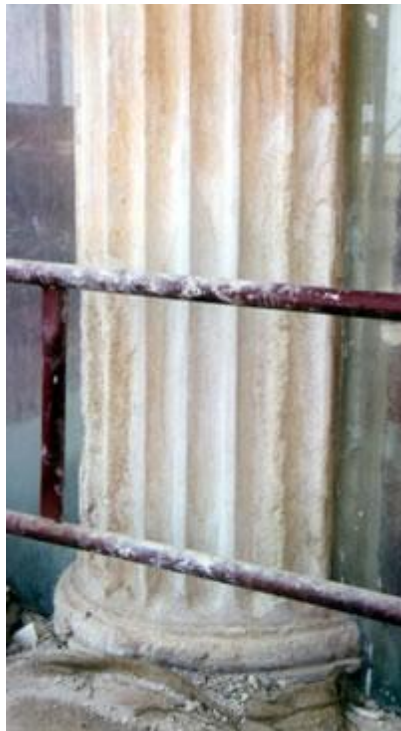
Intergration of stucco repairs with original volutes on Ionic column
